**Figure 1 Water sampling locations**

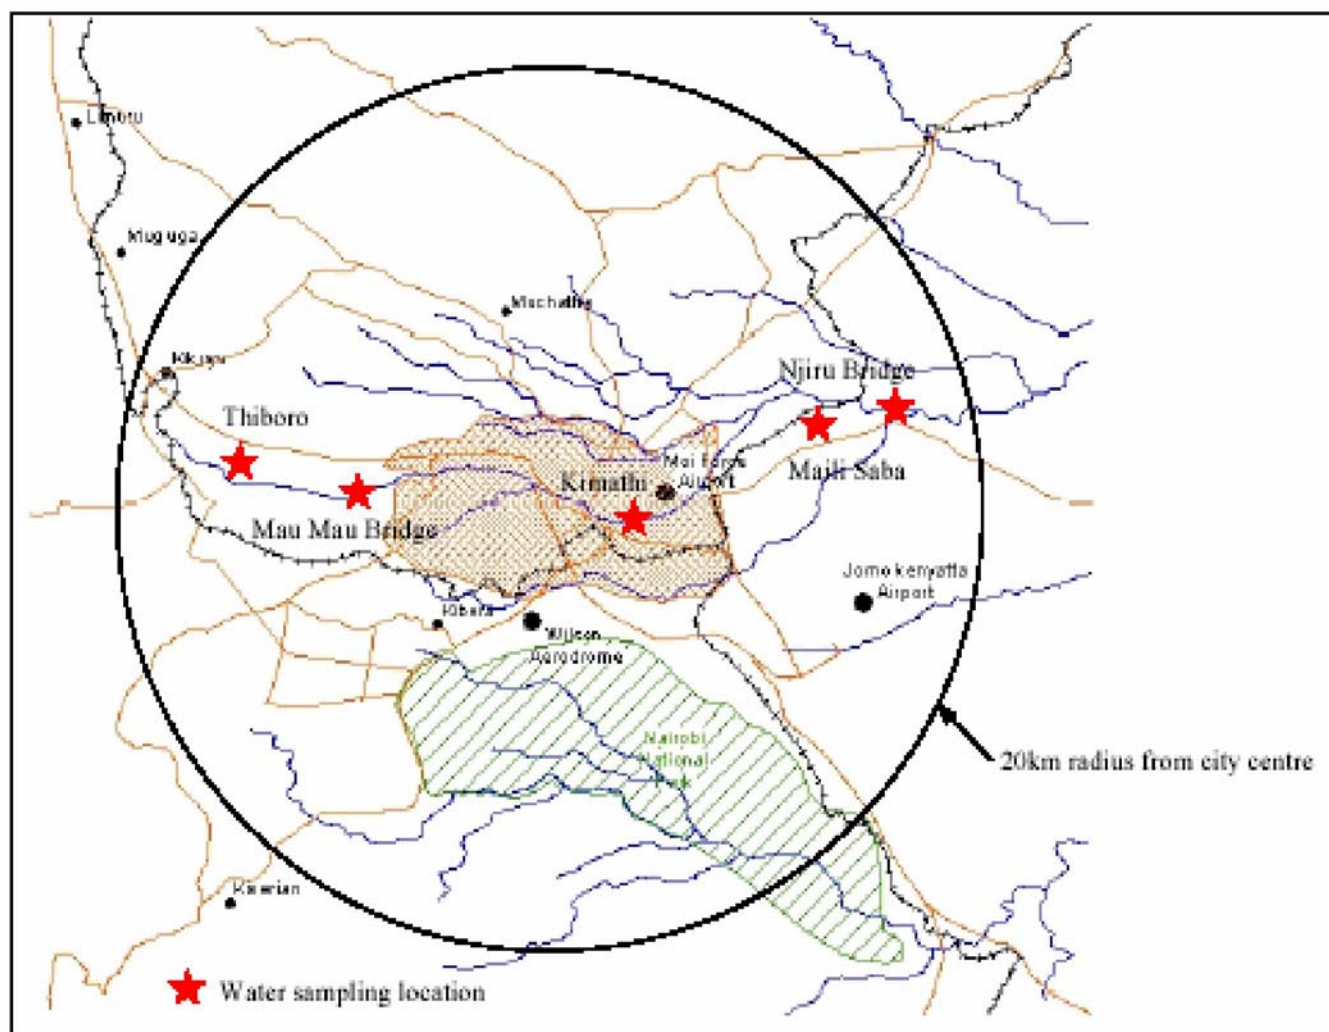
Five sampling sites were selected to provide an indication of the variation in water quality used for irrigation within the peri-urban zone. The focus of the study was on the Nairobi River, where three of the sampling stations were located: at Mau Mau Bridge, Kimathi and Njiru. Kimathi is located a few kilometres east of the city centre and just downstream of the main industrial area where crop irrigation occurs. Njiru is situated 20 km east of the city centre on the downstream edge of the zone defined by this project (figure 1). Weekly samples were also taken from a shallow well at Thiboro and at Maili Saba. Thiboro is semi-urban, highly densely populated with subsistence crop and animal agriculture taking place.
